USACERL Technical Report CRC-33-01
March 1993

World War II Temporary Military Buildings

A Brief History of the Architecture and Planning
of Cantonments and Training Stations in the United States

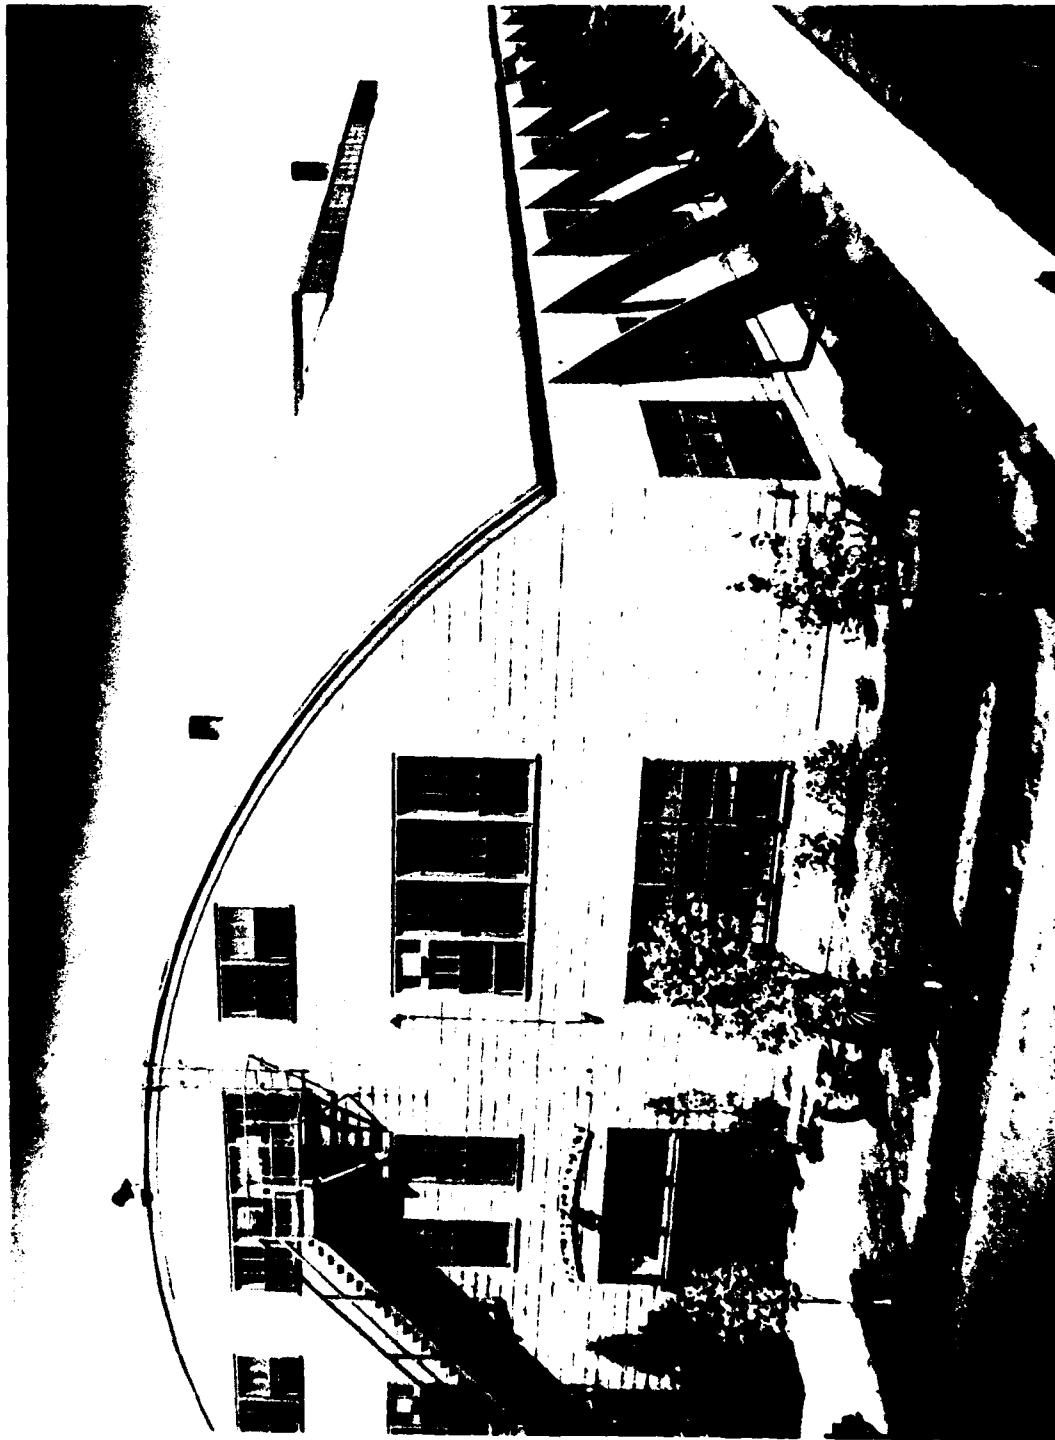
Figure 3.22. Laminated Arch Naval Drill Hall by Shreve, Lamb, and Harmon, 1943. (Source: Great Lakes Public Works Department.)

Perhaps the most important contribution to building design by the Navy during the war years was in the use of laminated trusses for drill halls. Also introduced in 1943, these large clear-span drill halls were designed by the New York architecture firm of Shreve, Lamb, and Harmon, the same firm that designed the Empire State Building. Again, because of material shortages, the use of steel in construction was limited by the War Production Board. Long-span wood trusses of the Pratt and Vierendeel type, with deep webbing between upper and lower chords, had been used by both the Army and Navy since World War I in theaters, hangars, drill halls, and other buildings requiring long spans. But the arch in comparison to deep trusses required less timber. Moreover, as seen in the Army field houses that used steel segmental arches, they offered greater floor-to-ceiling heights and more usable interior space. The drawback to using wood in an arch, however, was the problem of scarfing (splicing) together the laminations of dimensioned lumber. Nailing or bolting was impractical when many laminations were required. Compounding the problem was a shortage of high-grade structural timber. Much of what was delivered to construction sites was green—and poor quality at that. The design called for a 120 ft wood laminated arch, each arch spaced 16 ft apart for the length of the drill hall, or 625 ft total (Figures 3.22 and 3.23). Original specifications stipulated the use of 1 x 8s glued together and offset by scarf joints, to provide a cross-section 7.5 in. wide and 30 in. deep, made up of 37 laminations. Natural resin casein glues bonded the 1 x 8s, which were held in place under pressure and then heat-dried. The first applications erected at Sampson Naval Training Station were factory produced and shipped in two halves for final assembly. At other locations, the arches were sometimes fabricated on site within a sheltered space. Jack frames were used to shape the arches while laid out on the ground, and occasionally 2 x 8s were substituted for the lamination timbers. Green lumber with a moisture content above 15 percent and poor quality glue produced distortions and delamination in many of the field constructed trusses. Nevertheless, they were remarkable structures.^{3.27}

The arches, which acted in compression, carried the loads directly to the foundation. The end timbers were anchored to a concrete deadman that measured 3 ft, 3 in. by 6 ft, 6 in., with the long dimension on axis with the arch. Foundations were joined together under the floor of the hall by five three-quarter-inch reinforcing rods encased in concrete. The arches were stiffened laterally by four straight timber trusses set between each arch. The arches then carried 2 x 10 purlins spaced 16 in. on center, which received 1 x 6 sheathing boards and an outer covering of asbestos-cement panels. The floors were hardwood installed on a 6 in. concrete slab. At one end of the floor was a training pool, the sides of which were flush with the floor. From a center height of 39 ft above the floor, the curvature of the roof stopped about 12 ft above grade. Straight walls of 2 x 6 stud construction between the exposed ends of the arches continued perpendicularly to the foundation. Within the end bays of the drill hall were located lockers, showers, latrines, and offices. Composite windows made up of six-over-six and twelve-over-six lite configurations provided natural lighting in the end bays and every other 16 ft bay along the sides. Gangs of windows were separated by mullions, and a row of 24 in. steel sash pivoting windows formed a monitor at the top of the building for additional light and ventilation. A number of these remarkable drill halls still survive at Great Lakes and other locations, although they have been extensively altered.^{3.28}
